# **San Jacinto River Waste Pits Superfund Site**

**Temporary Cap Construction Completed July 2011**

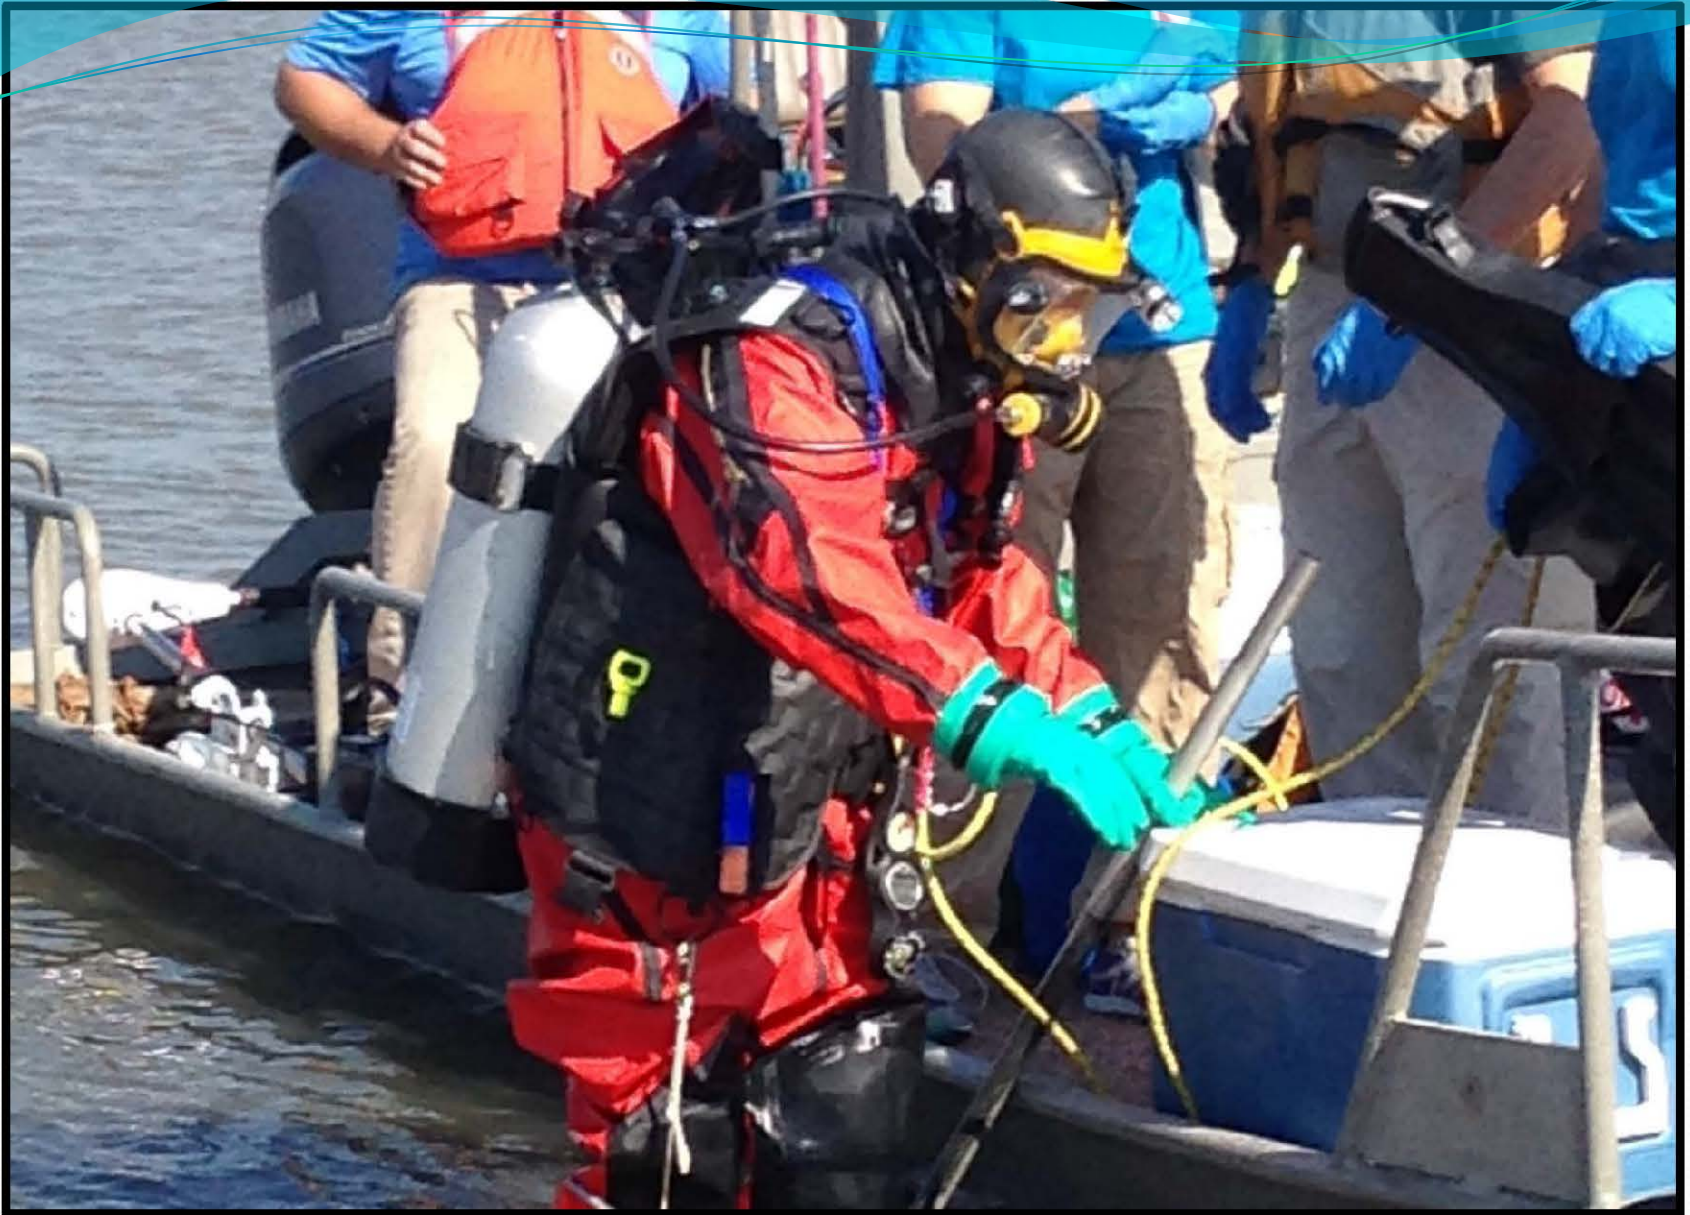
**EPA Dive Team inspection - Dec 2015**

**Damaged  
Area**

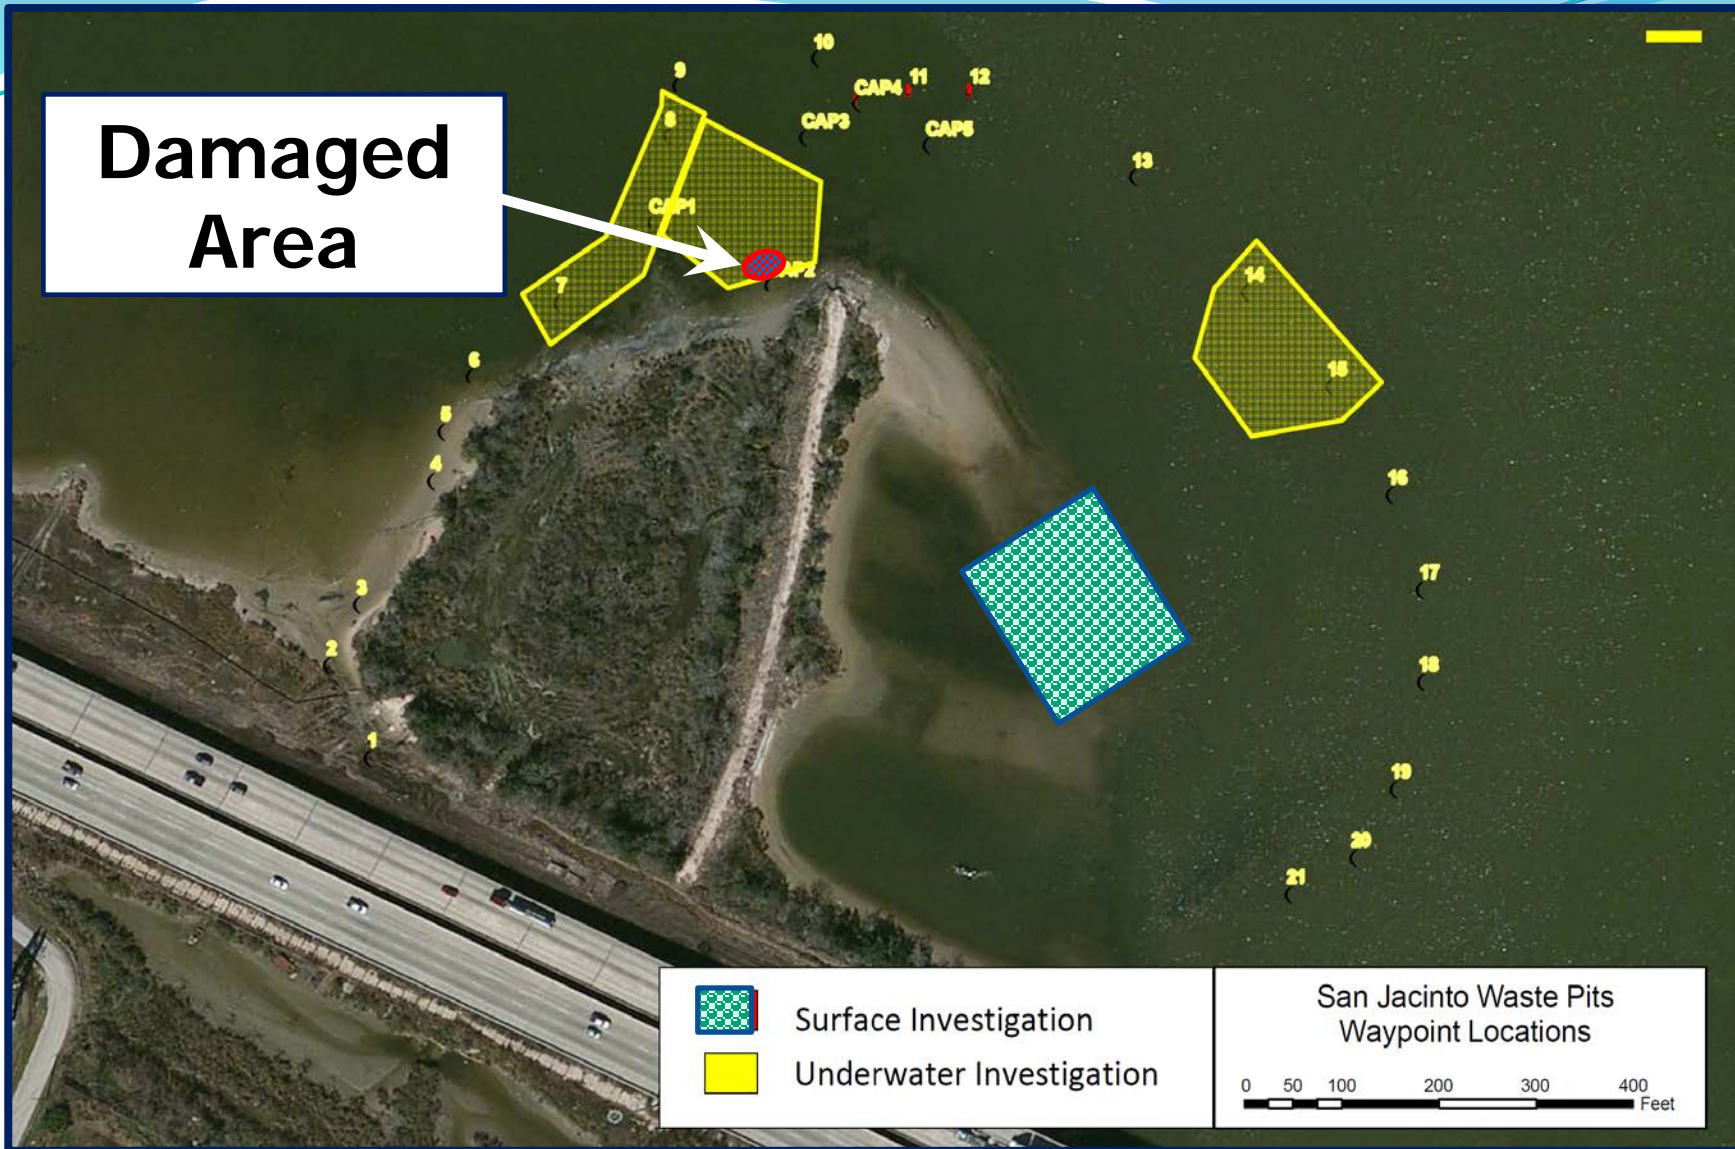
**Areas investigated by EPA Dive Team**

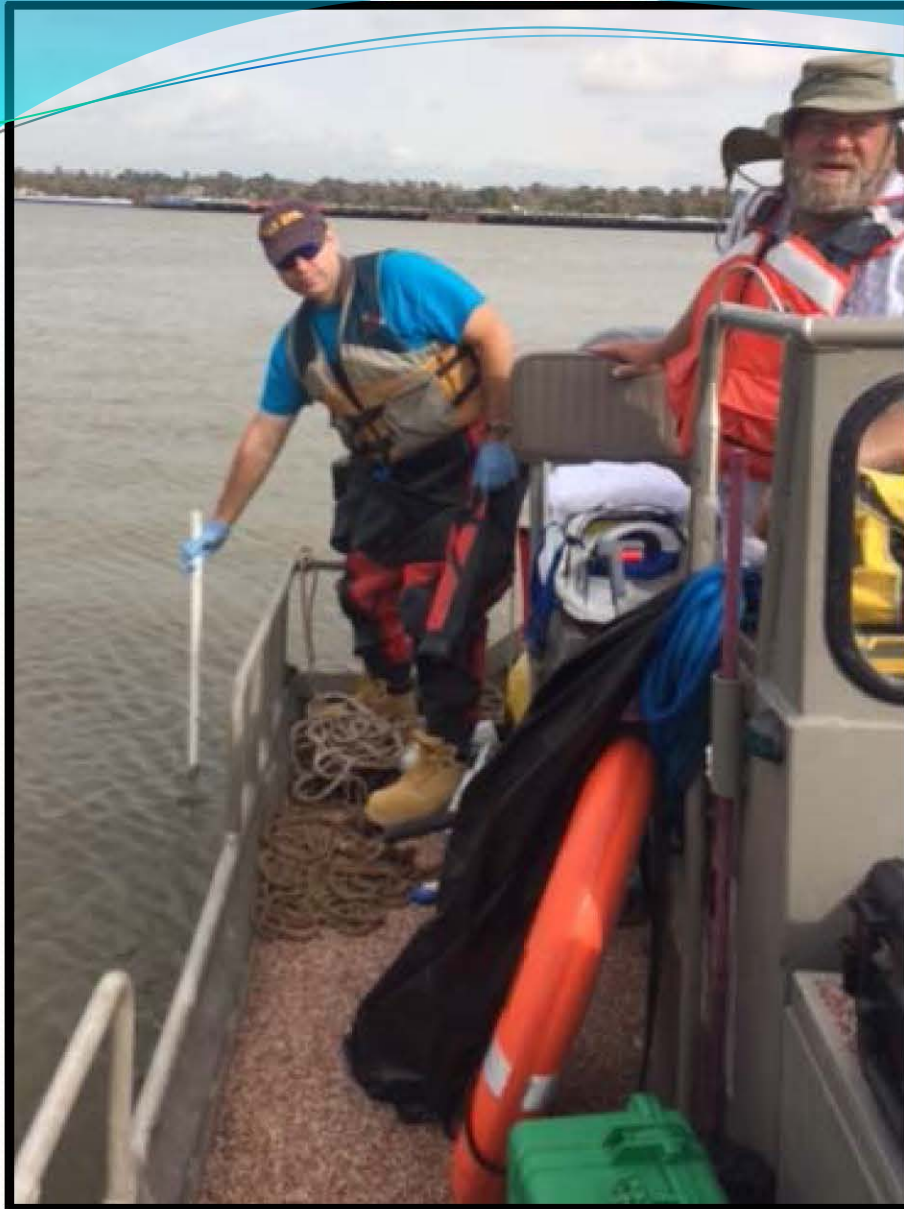
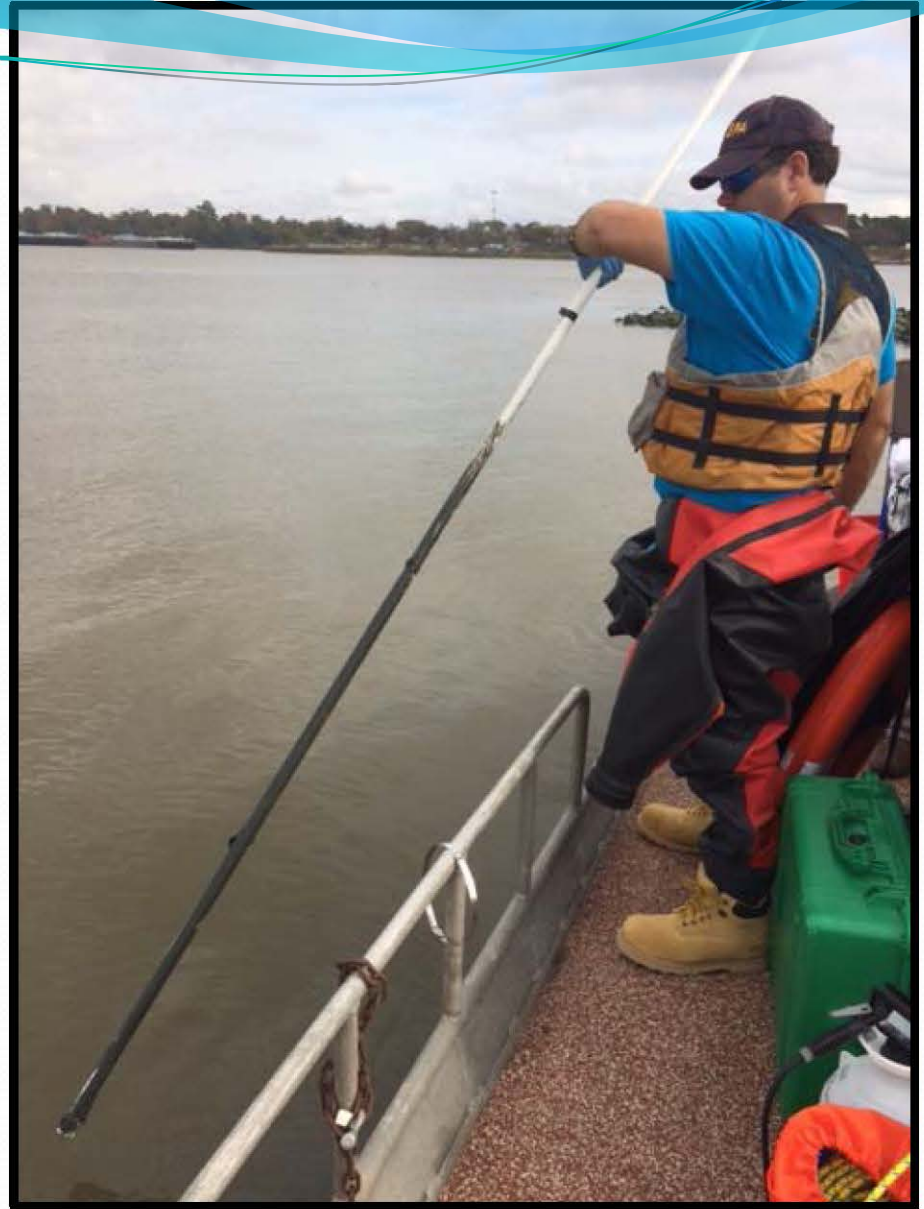
**Dive Team inspection Results**

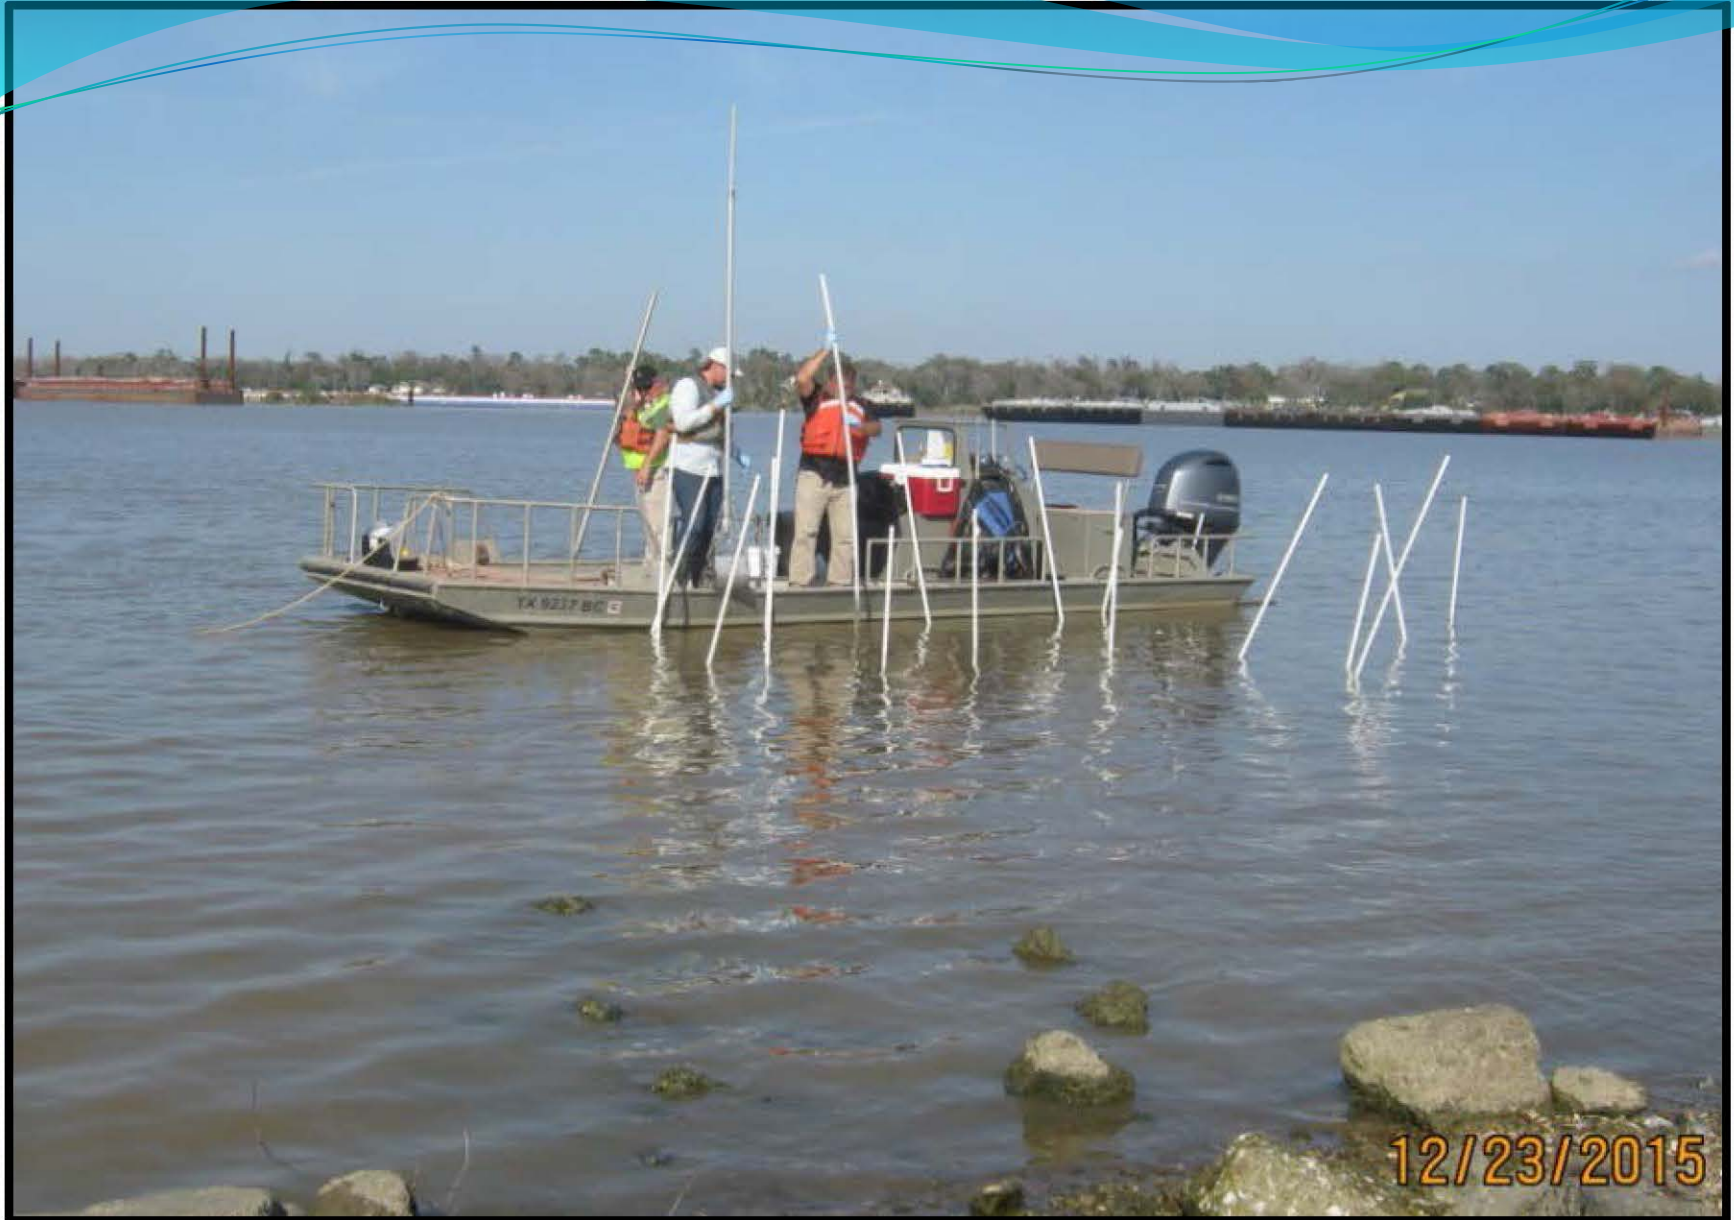
**Probing to define damaged rock area**

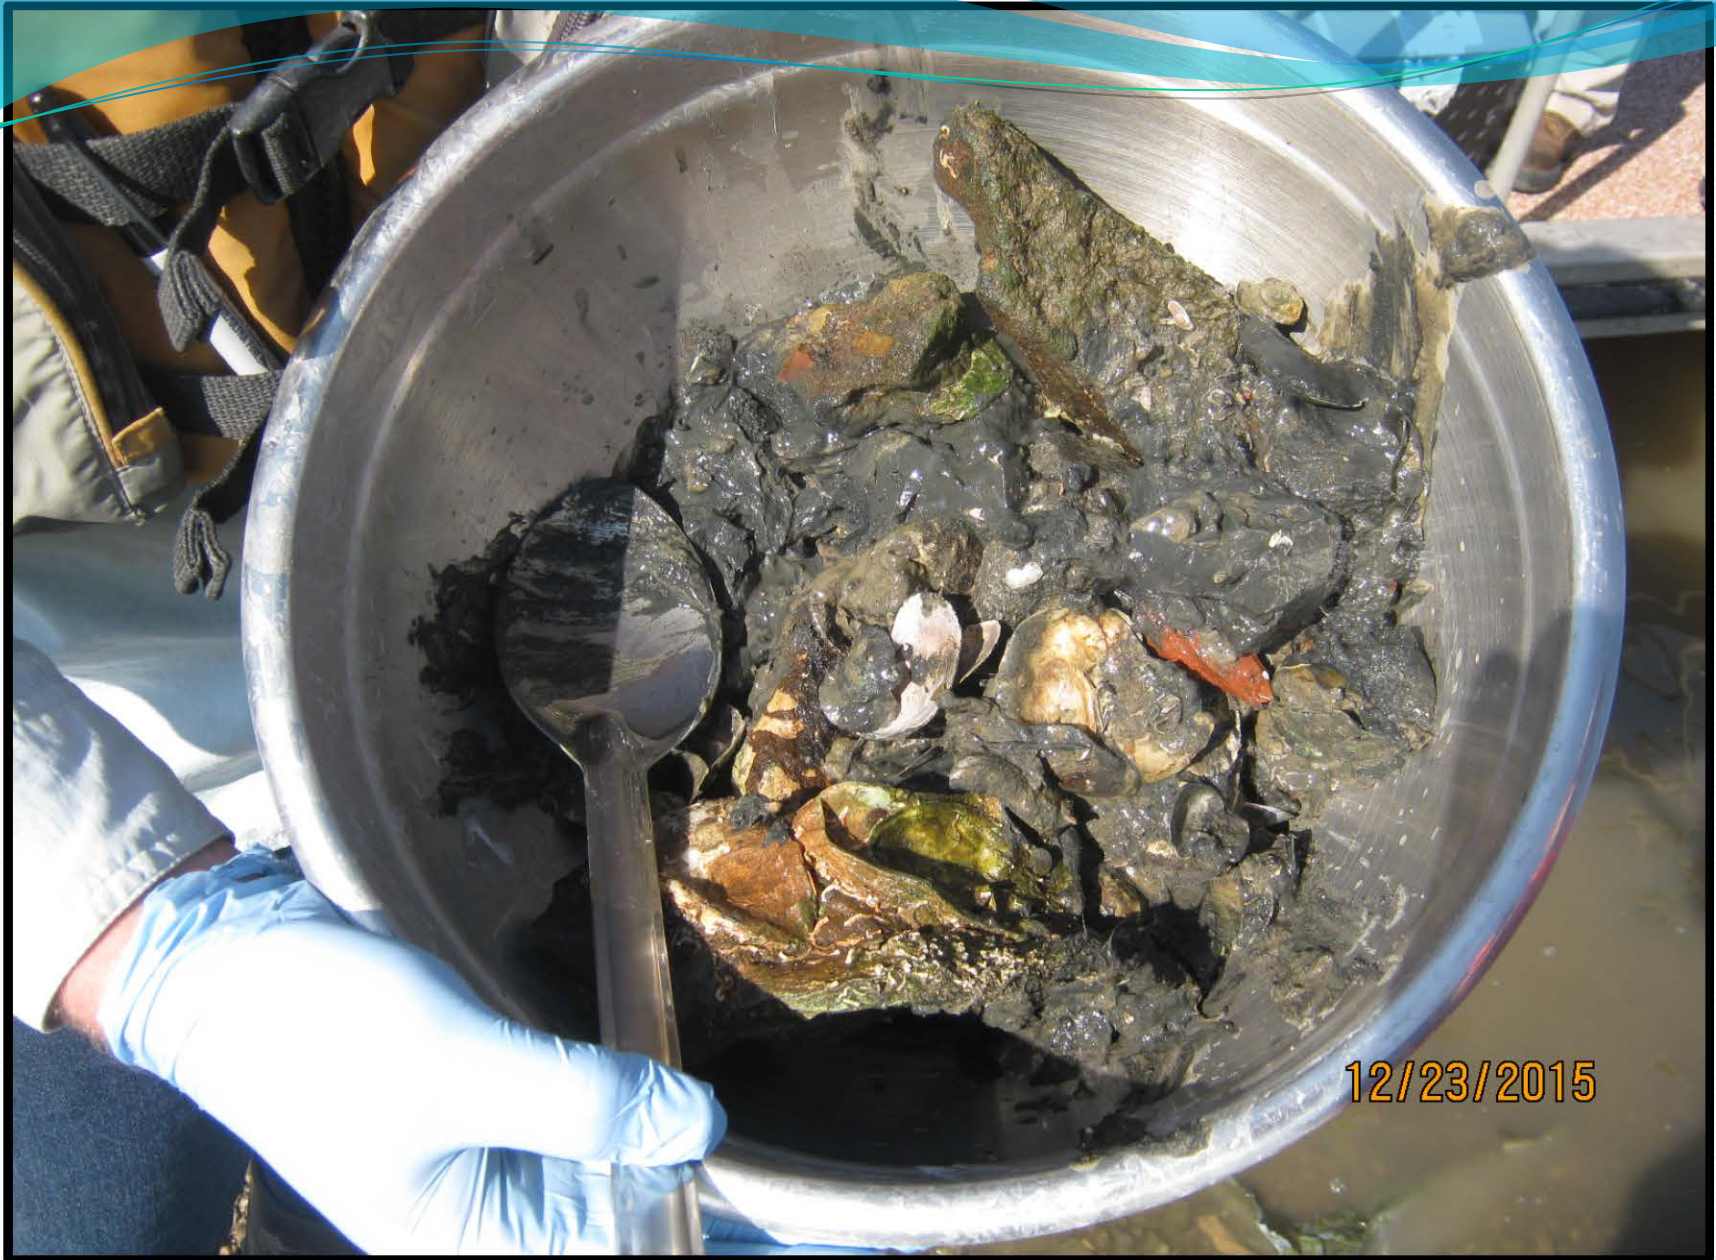
**Shallow sample from damaged cap.**
